Visitor Information Center

Current Status

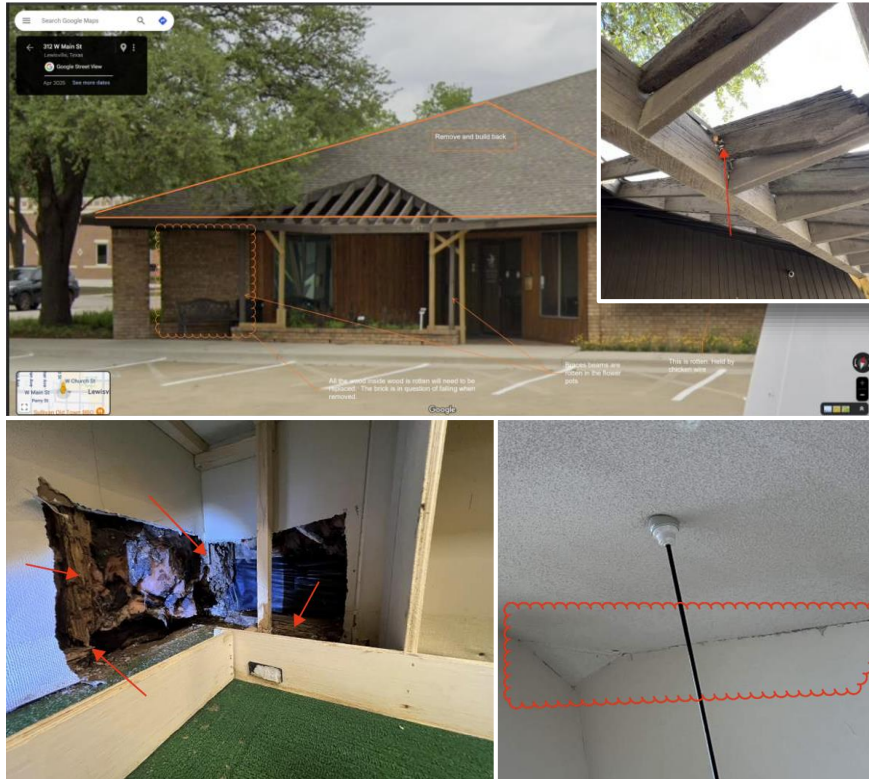
Front Entrance:

- Significant structural failure.
- Roof is sagging.
- Temporary shoring has been installed for safety

Southwest Corner:

- Severe wood rot in the wall studs

Westside Wall:

- Wood rot in the wall framing of both display room on west side.

Ceiling to Wall Separation:

- Cracking and separation at the high ceiling.

Recommended Immediate Repair or Demolition

Repair

- \$263,282

- Base Cost \$251,500
- Up to \$440,125
 - Contingency is included to address potential unforeseen issues that may arise once the roof load is removed from the structural beam such as:
 - Window frame deterioration
 - Internal wood framing damage
 - Compromised brick walls
