Appendix C

Intersection Audit Summary

For each of the 15 signalized intersections along the corridor, a high-level audit was conducted that considered elements of motorist and pedestrian/cyclist safety.

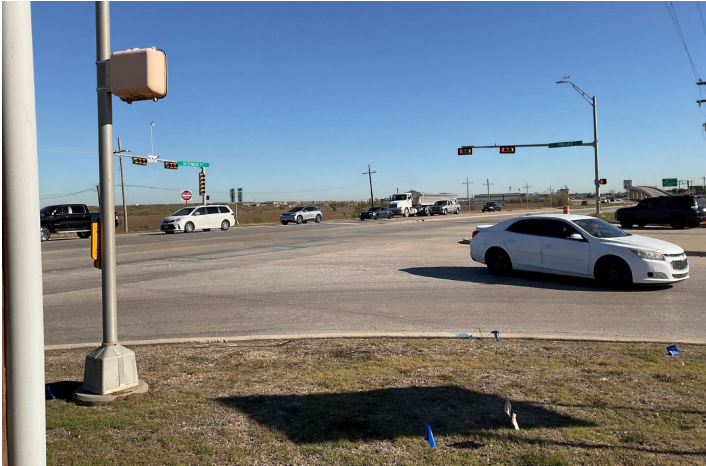
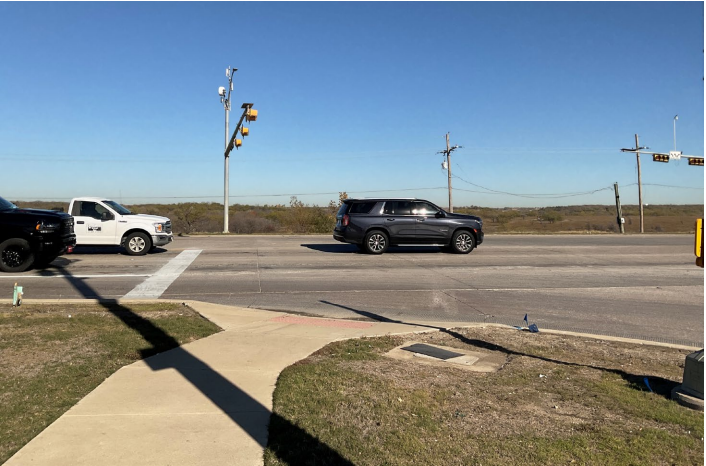
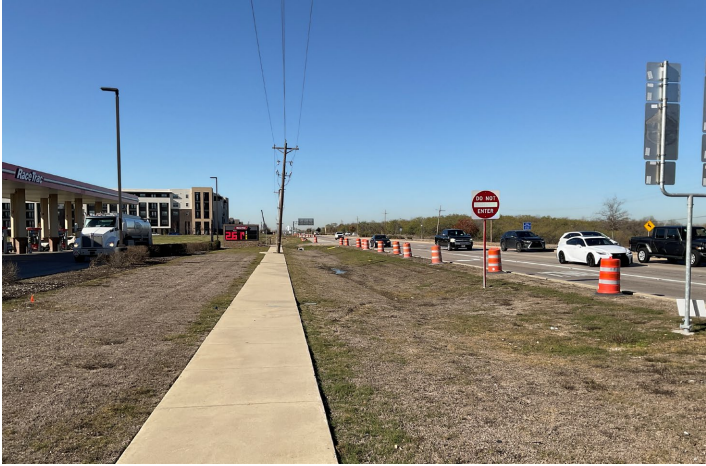
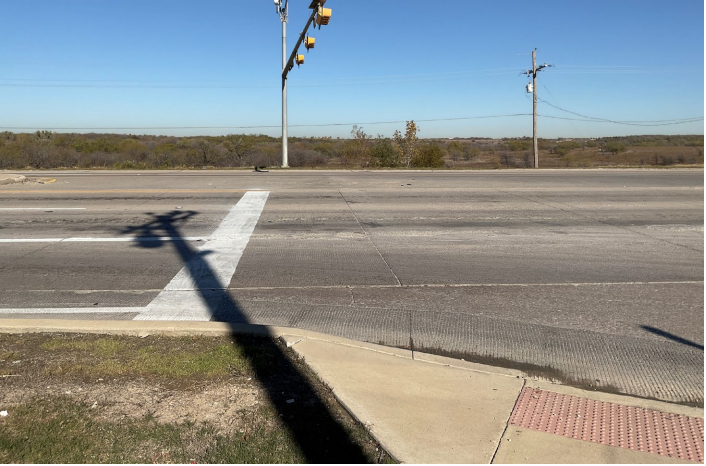
EXISTING CONDITIONS PHOTOS

What is the condition of the roadway pavement at the intersection? Damage to pavement in the northbound middle lane; some pavement panel replacements evident.

Is there evidence of past crashes, i.e. vehicle debris, skid marks, damage to the roadside and median areas? Minor debris collection at raised medians.

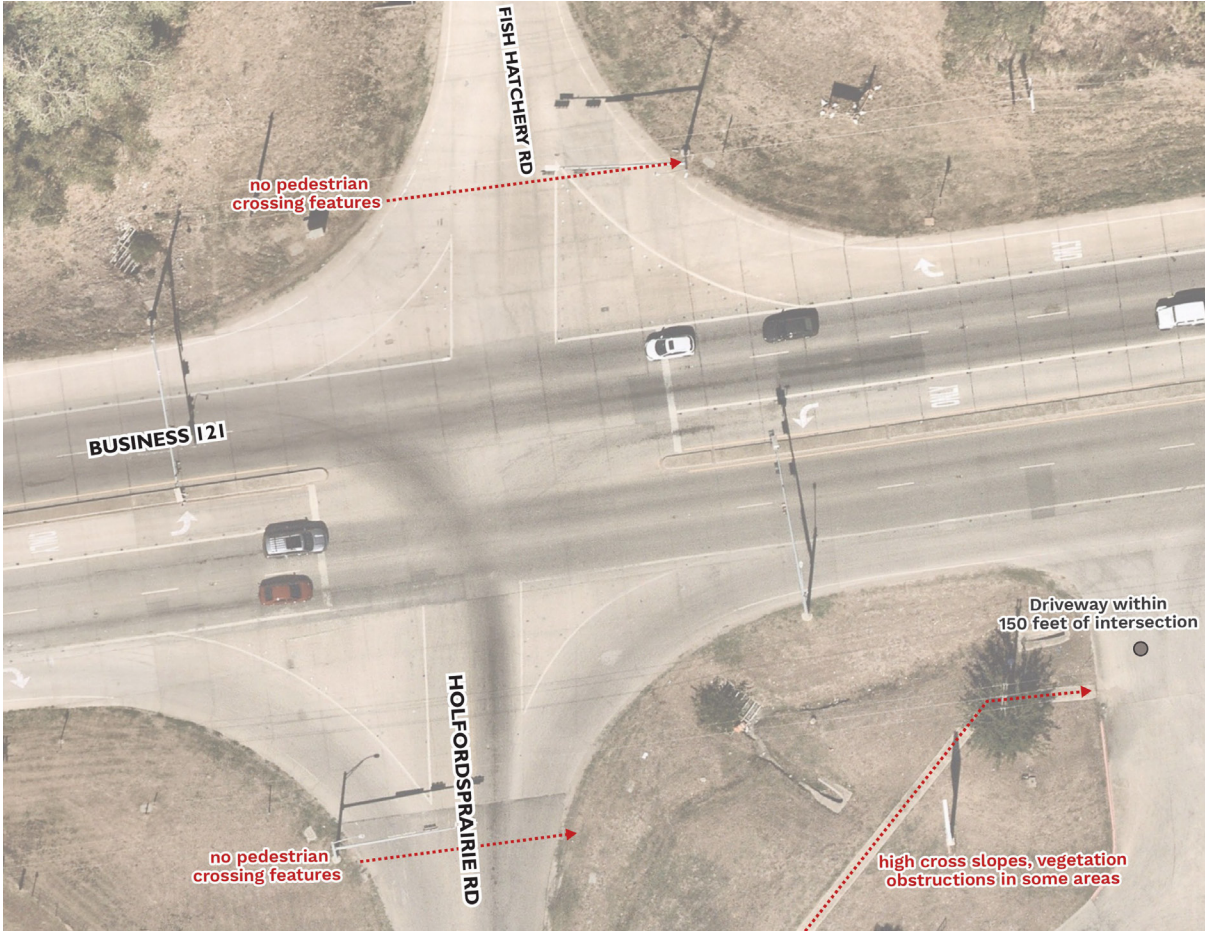
Fish Hatchery Rd leads to the Lewisville ISD Outdoor Learning Area (LISDOLA) and is not meant for through traffic. To the south, Holfords Prairie Rd is designated as a two-lane undivided collector on the thoroughfare plan that carries traffic to the businesses to the south of Business 121. In terms of motorist safety, there is a driveway within 150 feet of the intersection, which poses a safety issue as people start to accelerate away from the intersection. In terms of pedestrian safety, there are only existing sidewalks in the southeast corner of the intersection. These sidewalks are set a great distance back from the roadway so additional sidewalks will be needed to be able to connect to other sides of the intersection.

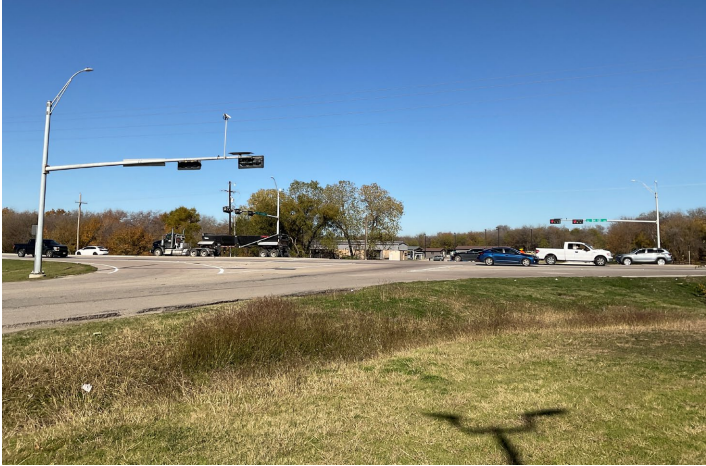
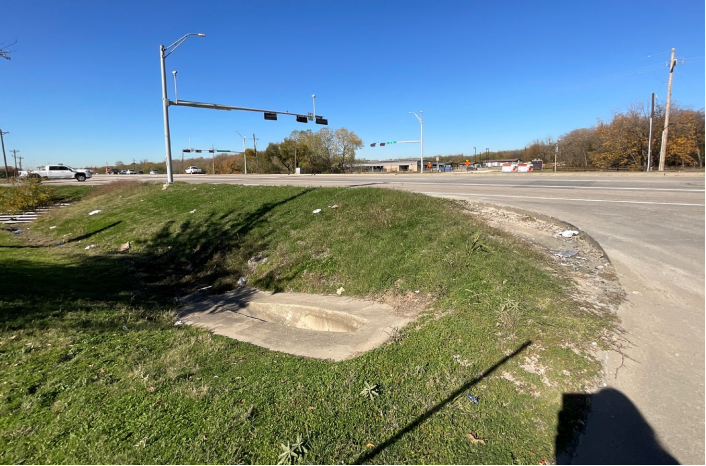
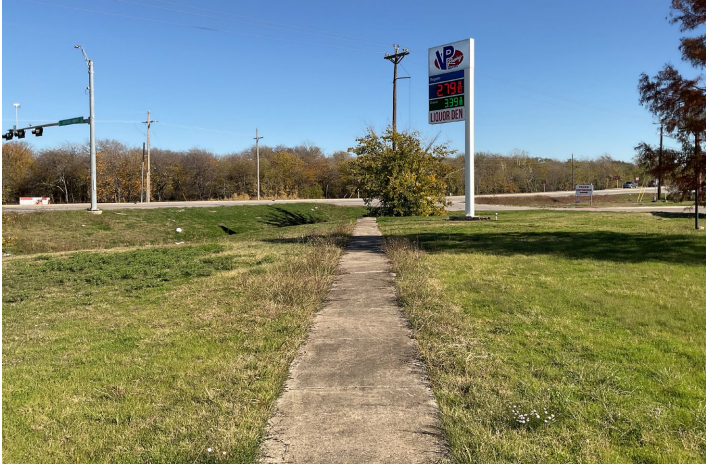
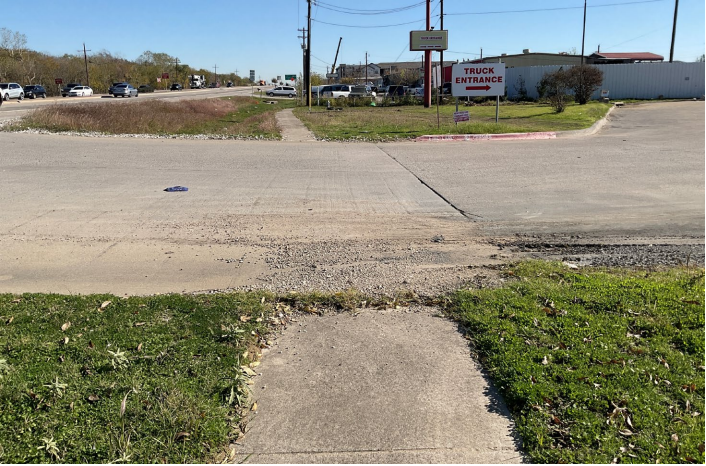
EXISTING CONDITIONS PHOTOS

What is the condition of the roadway pavement at the intersection? Asphalt on Holfords Prairie has some cracking/bumps

Describe the condition of the sidewalks. Are there cracks or uneven surfaces that would present dangers to cyclists or pedestrians? Narrow sidewalks (4') set back from the intersection; vegetation obstructions; some issues at joints and high cross slopes in some areas

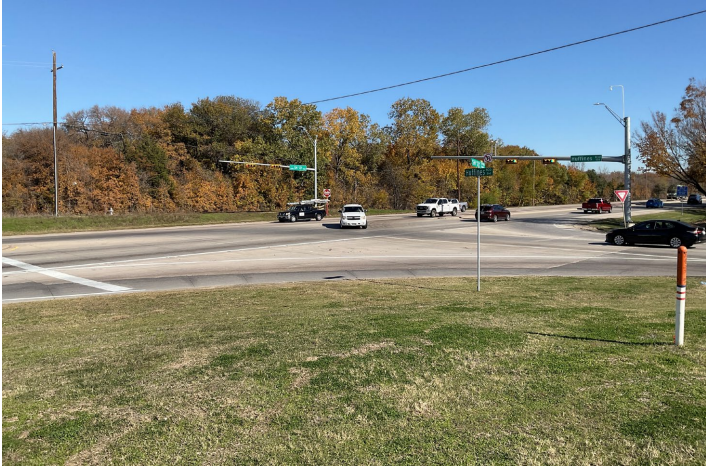
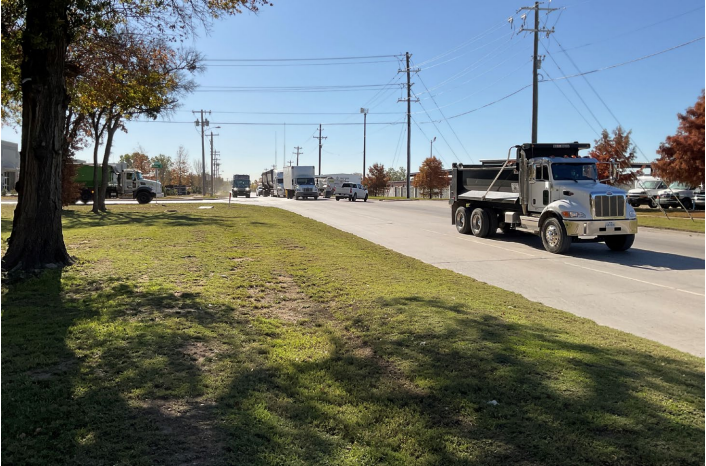
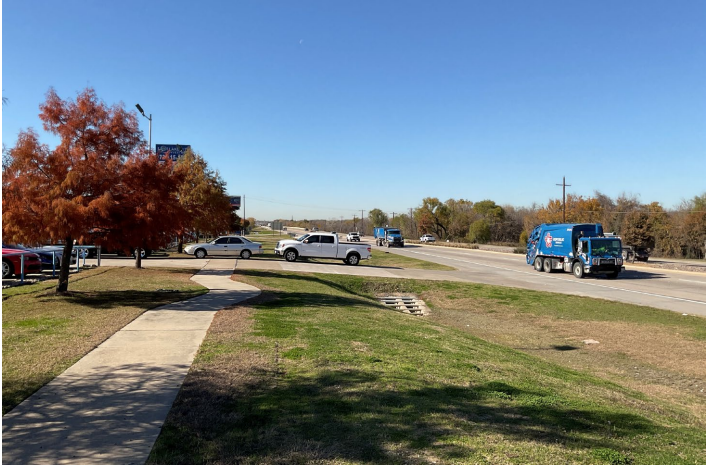
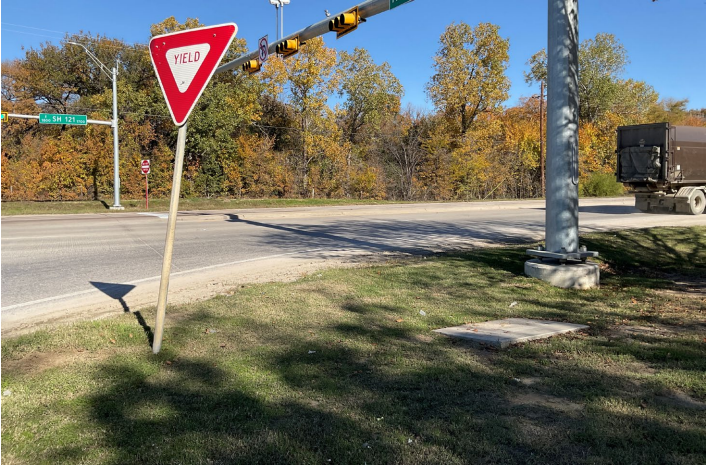
EXISTING CONDITIONS PHOTOS

Are signs worn, missing, or damaged? No, in good condition

What is the condition of the roadway pavement at the intersection? Good condition

Is there evidence of past crashes, i.e. vehicle debris, skid marks, damage to the roadside and median areas? No visible marks from past crashes

Describe the condition of the sidewalks. Are there cracks or uneven surfaces that would present dangers to cyclists or pedestrians? 5' sidewalks set back from roadway, appear in good condition

Is there a painted crosswalk? What kind (high emphasis, standard)? How is the condition? What is the total number of crosswalks? No painted crosswalks

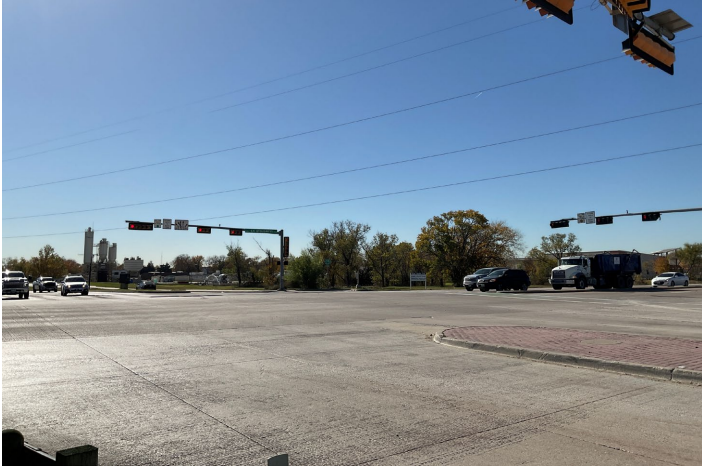
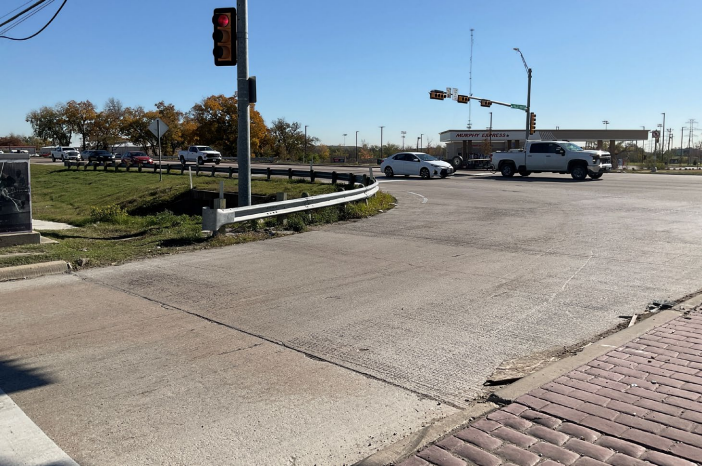
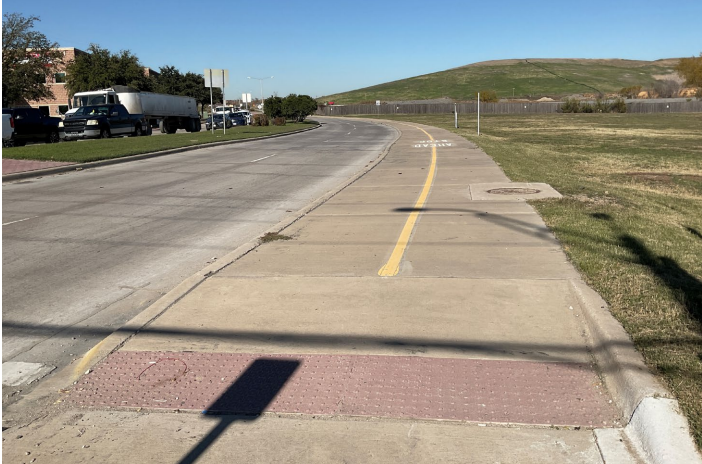
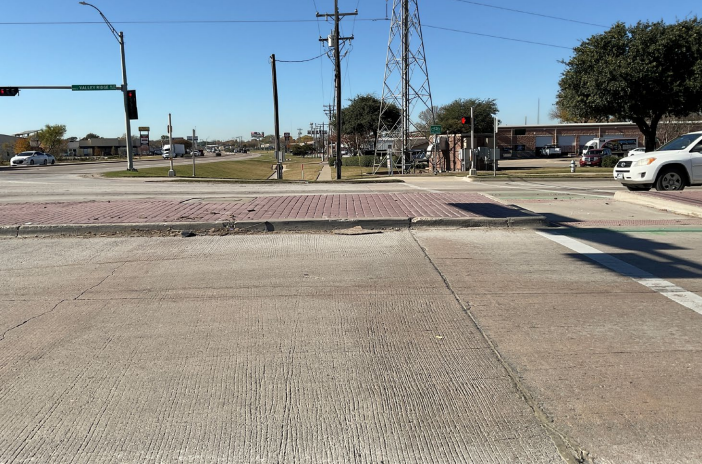
EXISTING CONDITIONS PHOTOS

Is there a painted crosswalk? What kind (high emphasis, standard)? How is the condition? What is the total number of crosswalks? Enhanced crosswalk on west side of 121 crossing, and north side of Valley Ridge crossing but green paint is faded; 3 total crosswalks

Describe the curb ramps at the intersection? SE corner: appears steep by ped push button, further than 10' from intersection, missing detectable warning; NE corner: side ped button further than 10' away; NW corner: side power pole in trail – doesn't meet width req, no lighting on pole or warning sign, detectable warning along radius due to distance from intersection, but may make users think they can cross sb and there is no receiving ramp on that side

Are dedicated bicycle facilities present? On which side(s) of the roadways? Are they continuous? Yes, cycle track across valley ridge. Striping is faded. Switches sides of the road at a very unsafe (felt unsafe due to driver behavior) crossing. The far side of the crossing is obstructed by a light pole, and goes from cycle track to bike track

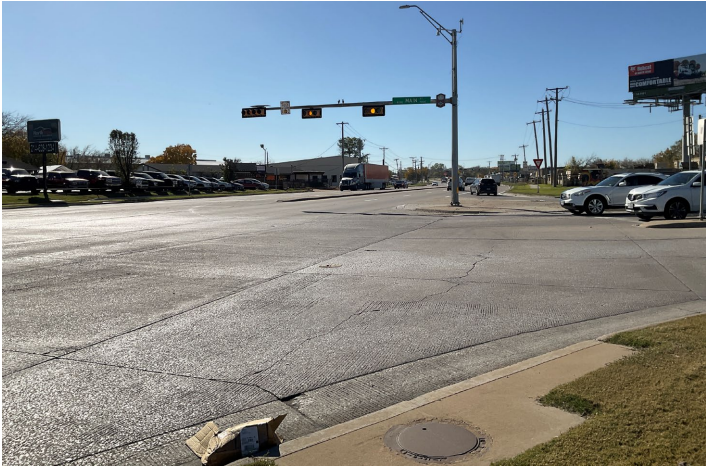
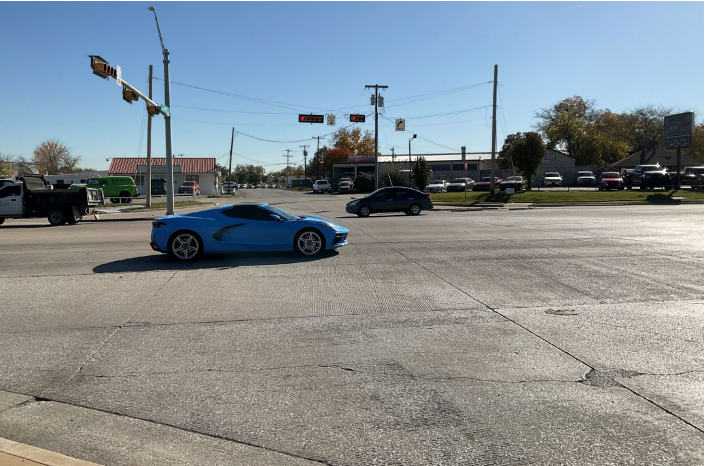
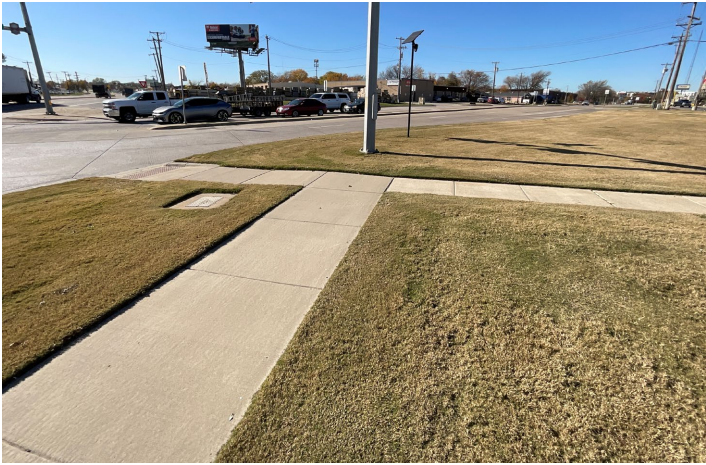
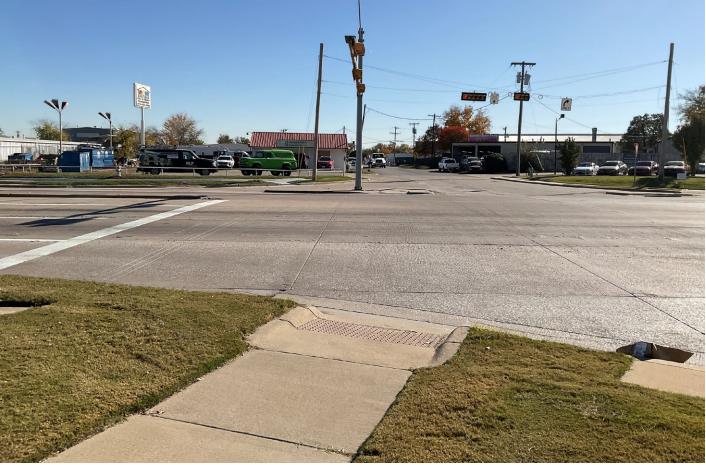
EXISTING CONDITIONS PHOTOS

Are signs worn, missing, or damaged? Yes, missing road sign for 121 on south side of intersection

Is there a painted crosswalk? What kind (high emphasis, standard)? How is the condition? What is the total number of crosswalks? No, crosswalk missing on all four sides

Describe the curb ramps at the intersection? Directional ramps don't line up with receiving ramps, median refuges cause additional crossing

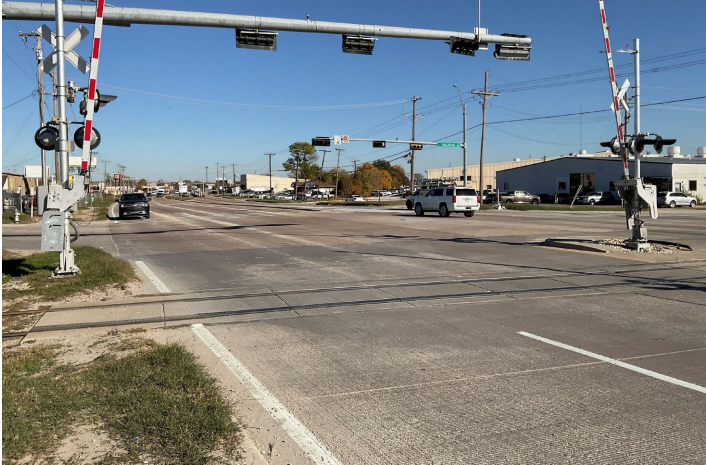
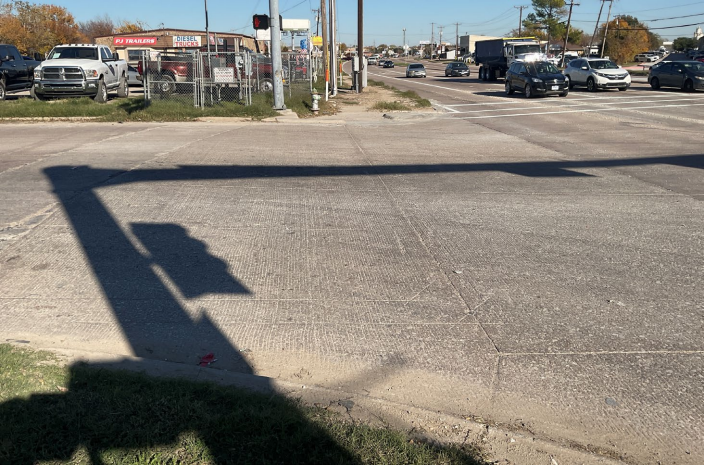
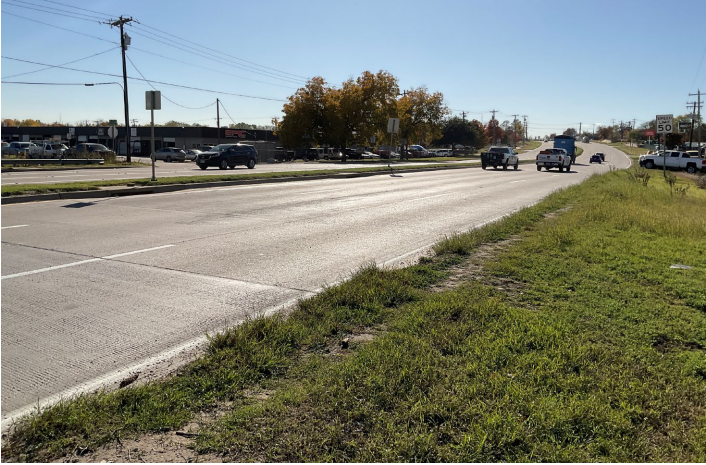
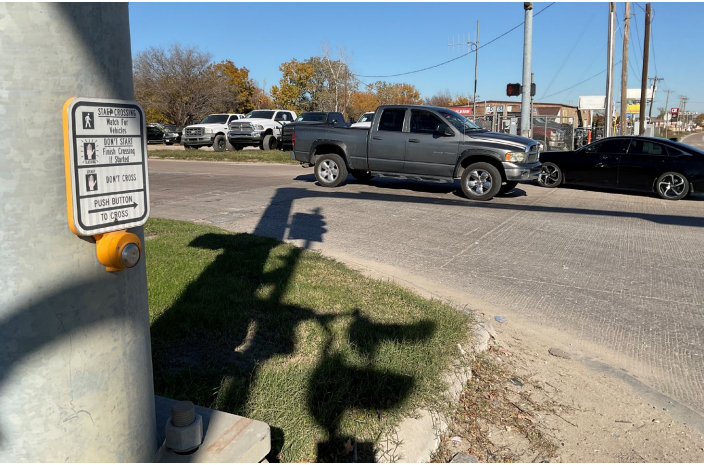
EXISTING CONDITIONS PHOTOS

What is the condition of the roadway pavement at the intersection? Some potholes and cracking, lots of debris on the road

Describe the condition of the sidewalks. Are there cracks or uneven surfaces that would present dangers to cyclists or pedestrians? Sidewalks on 121 are covered in dirt and debris; curb ramp is not accessible; back of curb

Describe the curb ramps at the intersection? Six total curb ramps, missing push buttons – only 1 direction each side

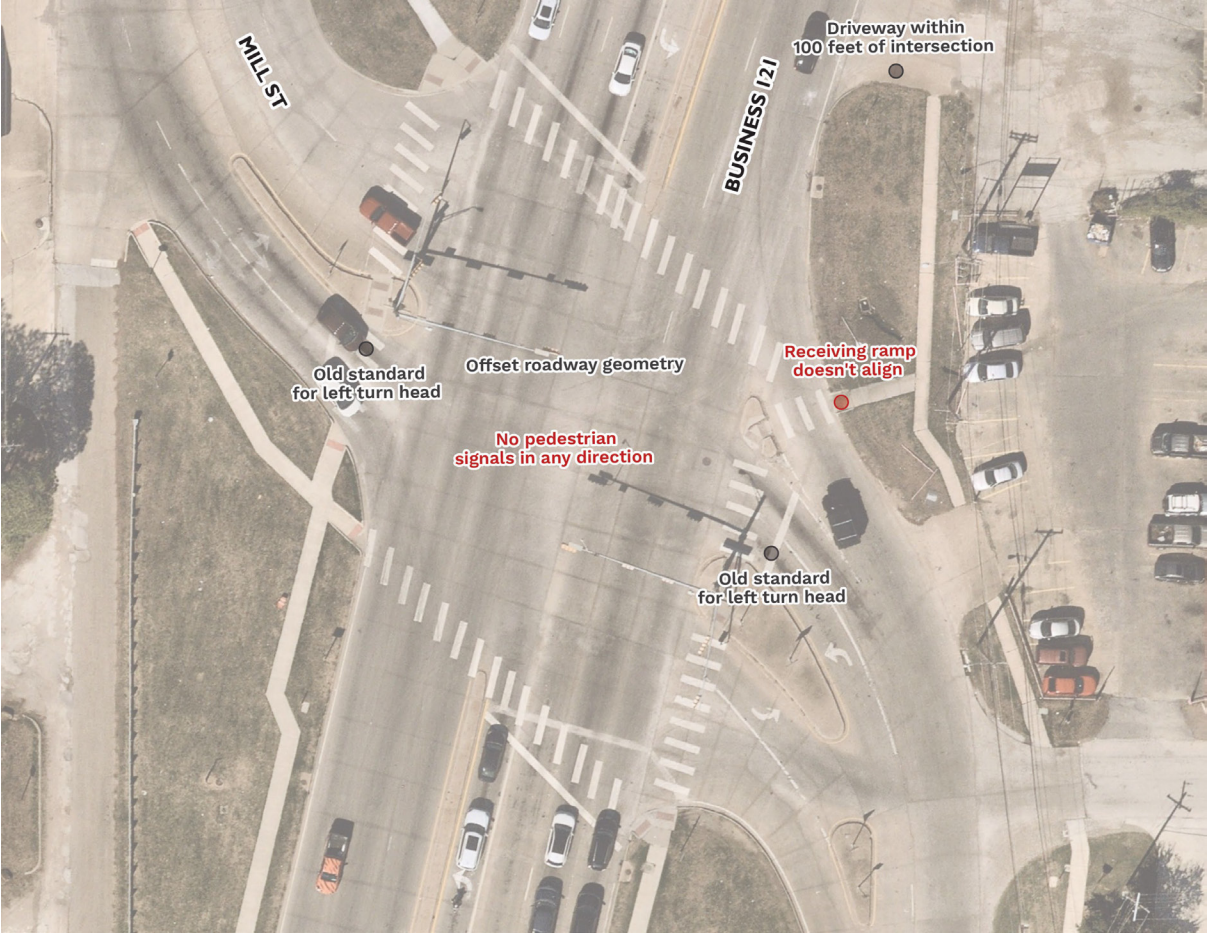
Mill St is identified as a four-lane undivided collector on the thoroughfare plan. In its current configuration, the roadway presents an unsafe intersection, but there are plans to realign Mill St. The current configuration of the intersection is offset, leading to driver confusion and long crossing distances for pedestrians. This is also the portion of the corridor with the highest concentration of signalized intersections within a short span, which leads to queuing issues. There is also a driveway within 100 feet of the intersection and no pedestrian signalization is present.

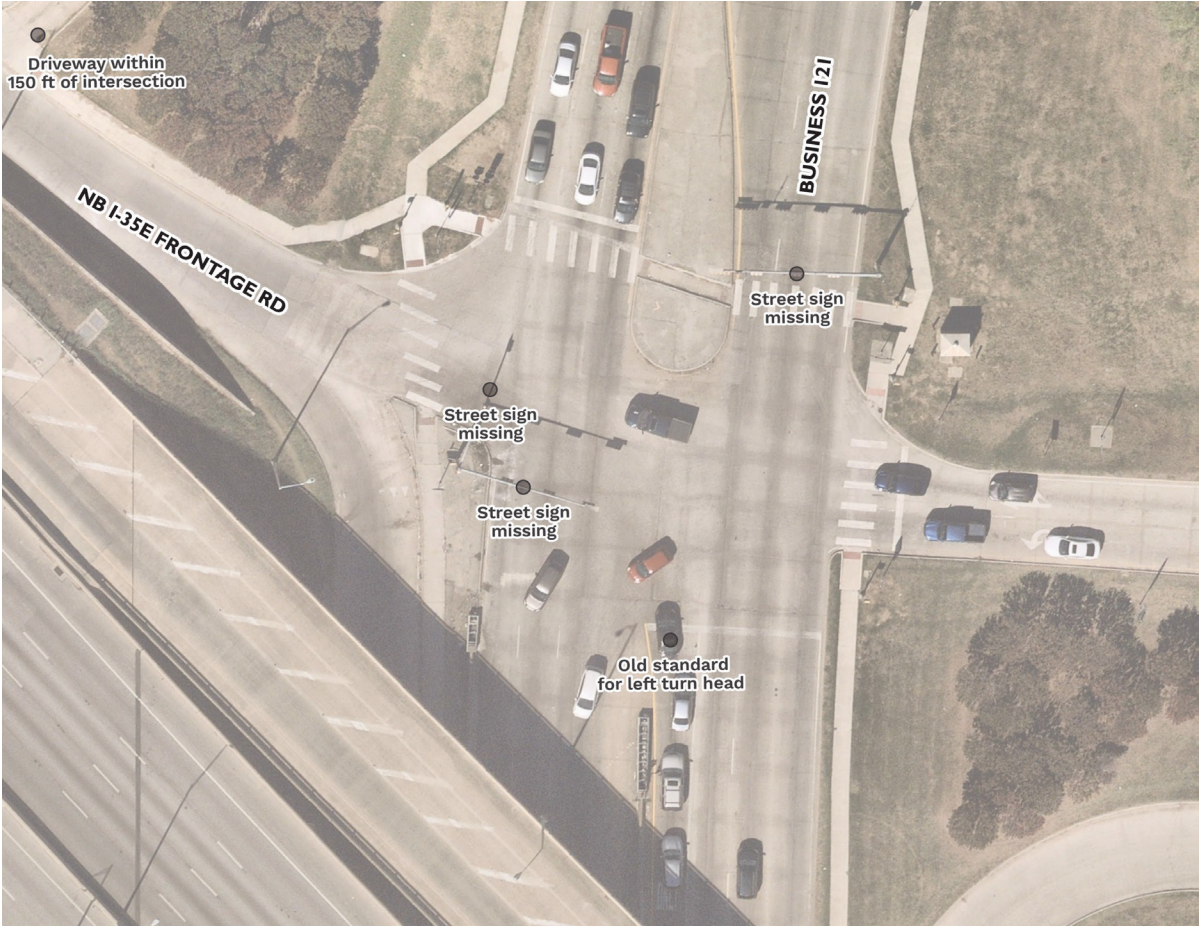
There is a signalized intersection at the northbound frontage road of IH-35E. The interchange at IH-35E is being reconstructed by TxDOT (see Planned Improvements section). This intersection is missing street signage in all directions, including interstate signage, which can cause confusion for people not knowing which direction they are going on IH-35E. There is also significant vehicle queuing and a driveway within 150 feet of the intersection. This intersection does feature newly reconstructed sidewalks and curb ramps as part of the TxDOT IH-35E reconstruction project.

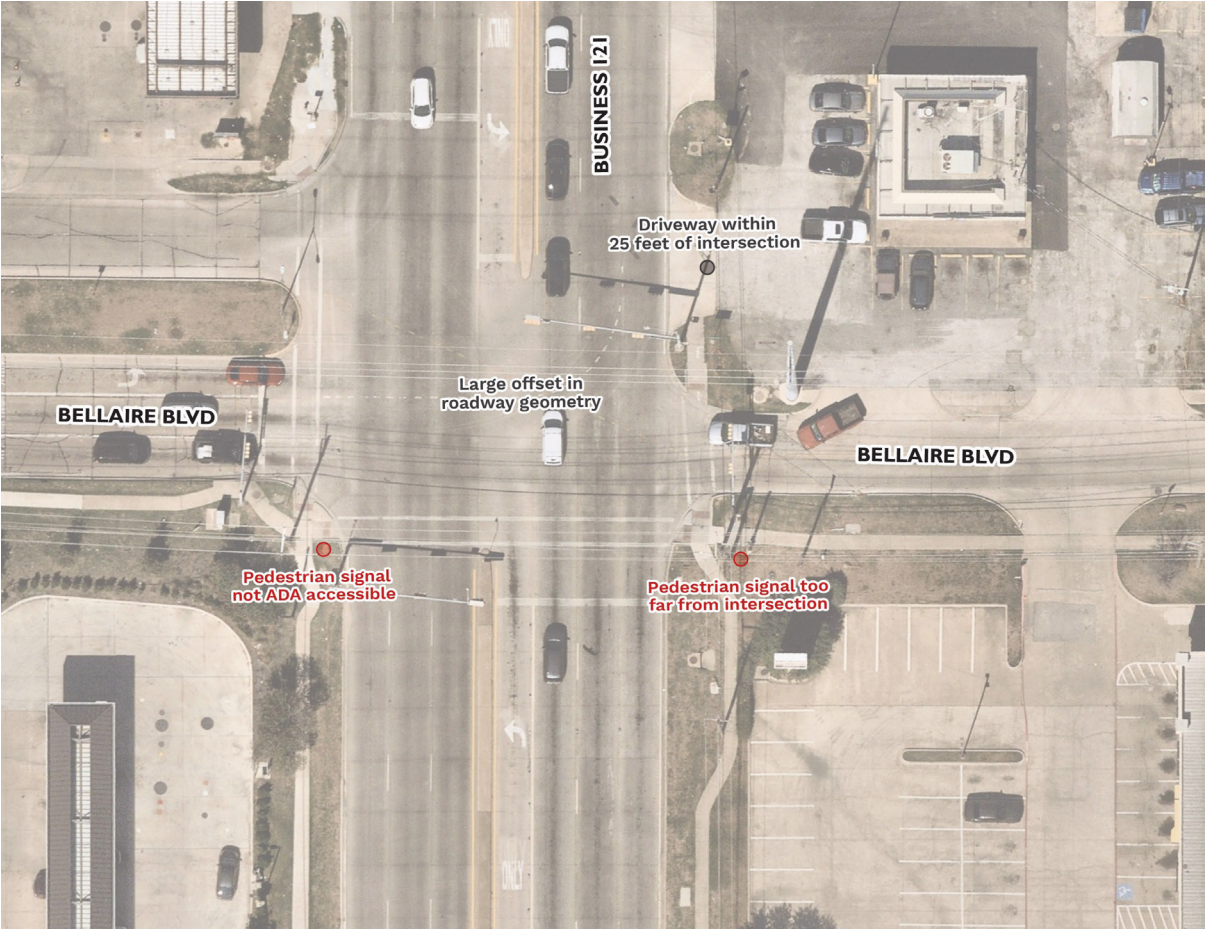
To the west of Business 121, Bellaire Blvd is identified as a four-lane divided principal arterial. The roadway is an east-west connector in the city providing access to many residential neighborhoods. For motorists traveling through the intersection on Bellaire, the alignment is offset and confusing. Additionally, the closest driveway to the intersection is less than 25 feet. Additionally, the intersection features faded crosswalk paint where there are crosswalks. Finally, this intersection had the highest number of motor vehicle accidents of any signalized intersection along the corridor in the past three years.

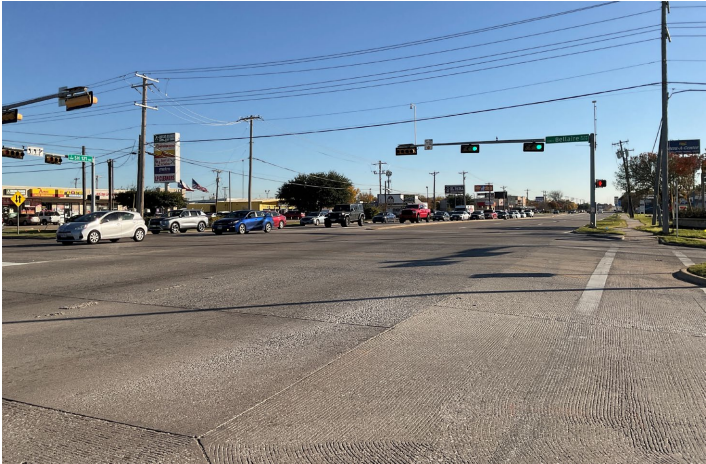
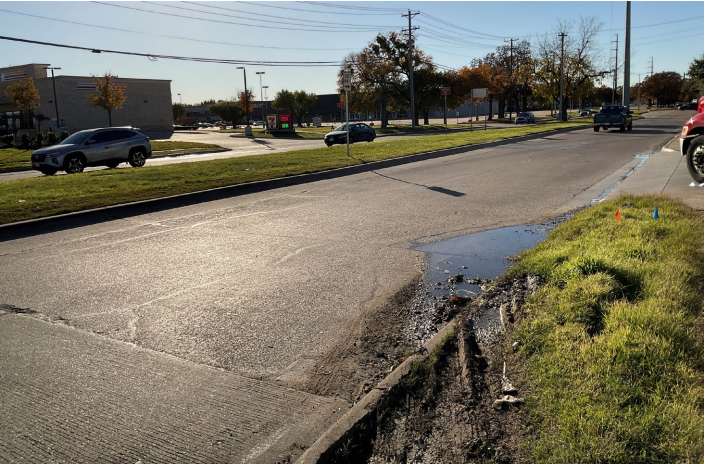
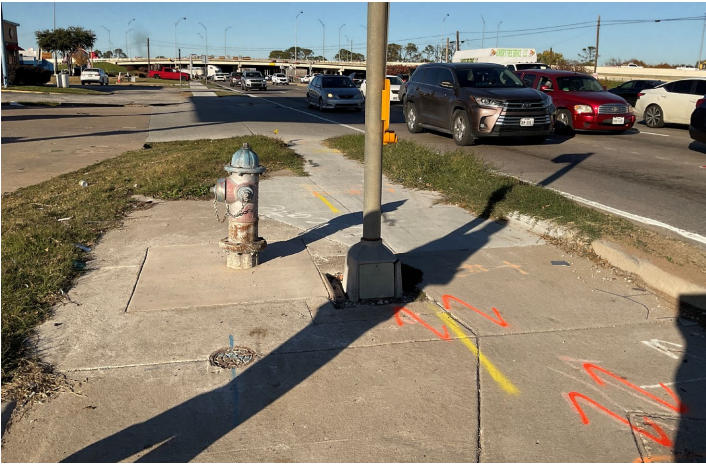
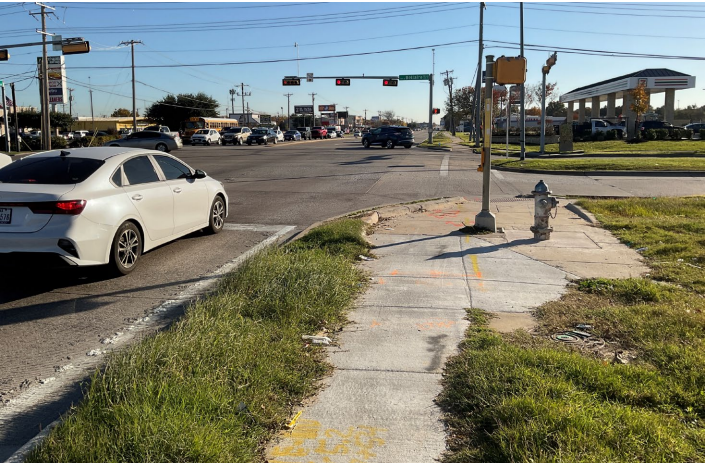
EXISTING CONDITIONS PHOTOS

What is the condition of the roadway pavement at the intersection? Normal wear and tear, trucks seem to jump the curb going eastbound causing some damage

Is there a painted crosswalk? What kind (high emphasis, standard)? How is the condition? What is the total number of crosswalks? Yes, standard striped crosswalk on three sides of the intersection; paint is faded in parts

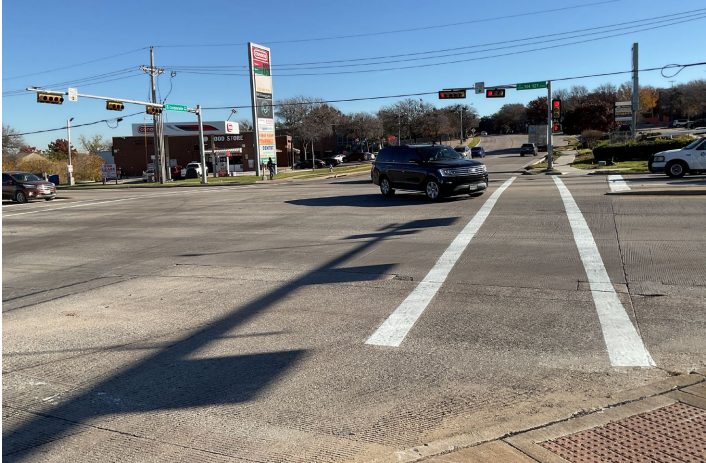
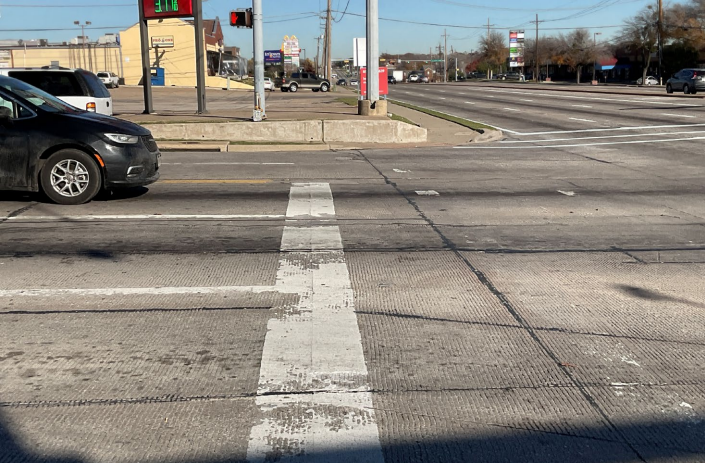
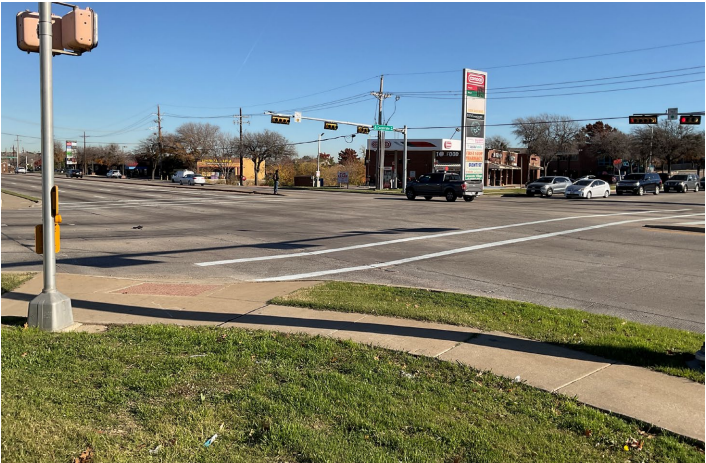
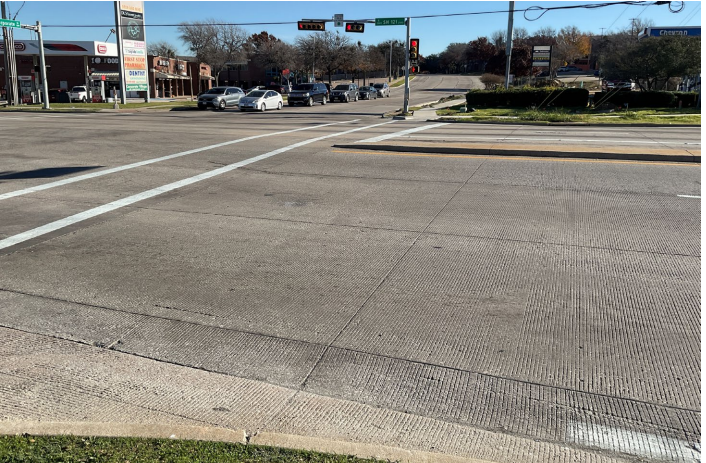
EXISTING CONDITIONS PHOTOS

Are signs worn, missing, or damaged? Missing – southbound 121 street sign is missing

What is the condition of the roadway pavement at the intersection? Some wear at joints, potholes, have filled in some potholes

Is there a painted crosswalk? What kind (high emphasis, standard)? How is the condition? What is the total number of crosswalks? Yes, standard crosswalk on all sides; worn paint on both sides of Corporate

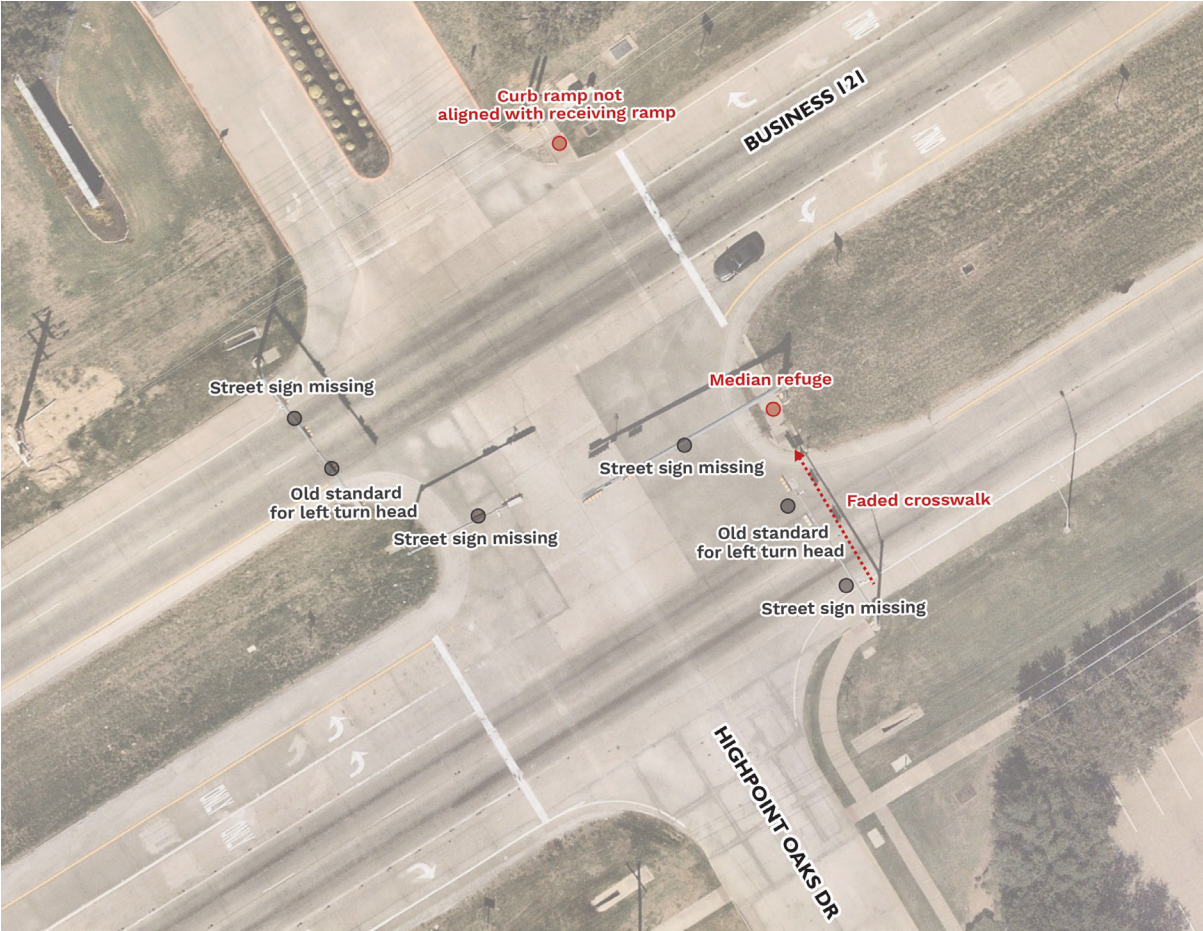
This roadway is designated as a local street on the Thoroughfare Plan and primarily serves the Convergence Business Center area. Street signs are missing in all directions at this intersection, which causes a safety issue for visitors and delivery vehicles trying to find specific offices. Additionally, unprotected left turns are allowed in both directions on Highpoint Oaks, but the signage is the old yield on green standard. As for pedestrian safety, there is a median refuge in the northern crossing of Business 121, but due to the length of the crossing and light timing, pedestrians are forced to stop and wait in the median, which is not a comfortable experience. There are also issues with curb ramps not aligning with the receiving ramps.

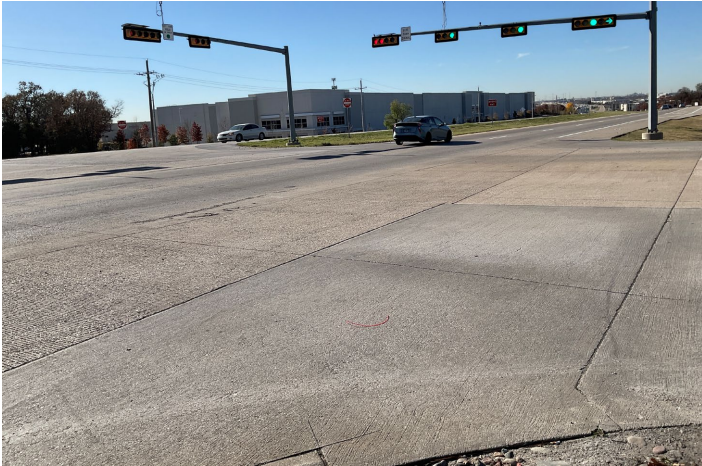
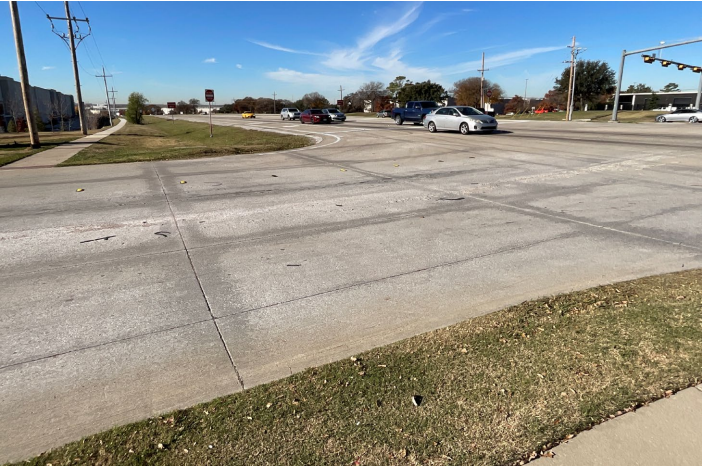
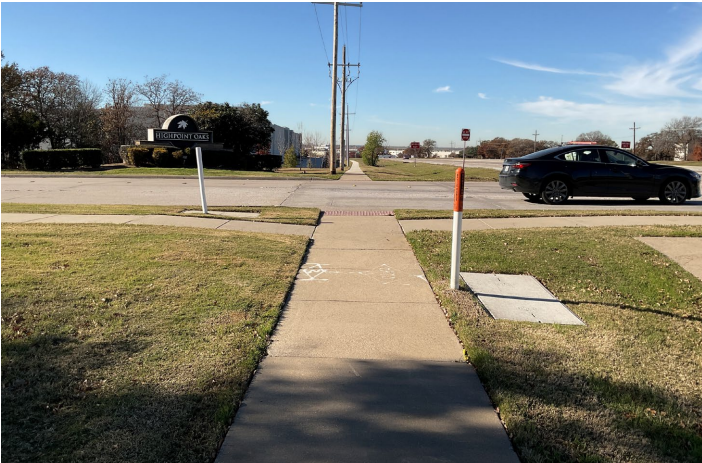
EXISTING CONDITIONS PHOTOS

Are signs worn, missing, or damaged? All street names are missing

Describe the condition of the sidewalks. Are there cracks or uneven surfaces that would present dangers to cyclists or pedestrians? Good buffer distance from roadway, some cracking and separation at joint evident

Describe any pedestrian signalization at the intersection. Old style push button, over 10' away from intersection on east side and in median refuge; ped button missing on north side of 121 to cross Highpoint Oaks
